Manhole Inspection Summary

Manhole # S59AA_001MH

Insp Date: **3/20/08 2:42 PM**

Location Address: **PULASKI HWY**

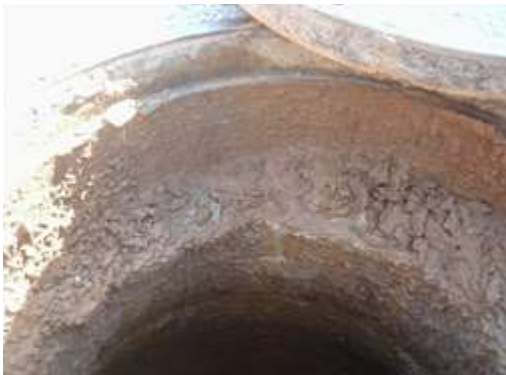
Defect 2

Chimney / Frame Adjustment ☒ Exists Material: **Brick** ☐ Parged Height: **9** (in.)
Condition: ☒ Sound ☐ Cracked ☐ Root Intrusion ☐ Loose Brick ☐ Deteriorated
Infiltration: ☐ None ☒ **Joint** ☐ Cracks ☐ Mortar ☐ Roots ☒ **Wall**

ADJUSTMENT JOINT

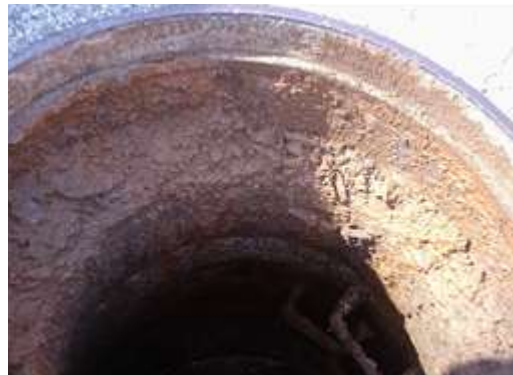
Defect 1

Frame Offset: **0** (in.) Condition: ☐ Sound ☐ Cracked ☒ **Leaks**

FRAMELEAKS

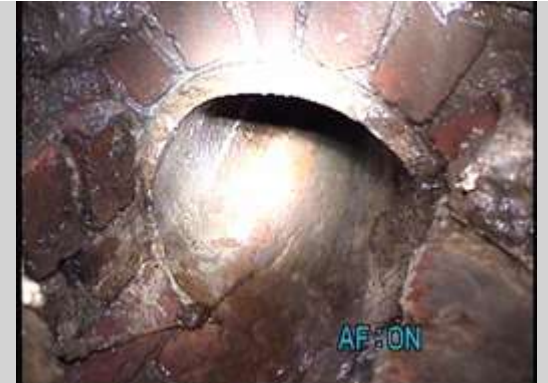
12 O'Clock Outflow

10 in. Circular Gravity Sewer
Pipe Out @ 12 O'Clock

Pipe Height: **9.6** (in.) Rod and Bar (Angled)
Pipe Material: **Clay** ☐ Pipe Lined
Invert Depth: **8.90** (ft.) Flow Characteristics: **Slow**
Deposits: ☐ None ☒ **Mud** ☒ **Sludge** ☐ Debris ☐ Grease
Silt Depth: **4** (in.) Deposits Extent: **Medium**
Infiltration: **None** Pipe Seal Cond: **Sound**

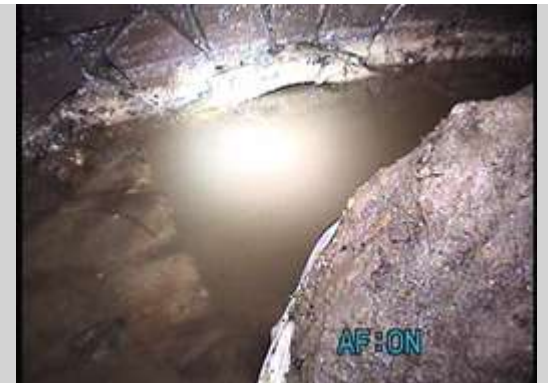
7 O'Clock Inflow

10 in. Circular Gravity Sewer
Pipe In @ 7 O'Clock

Pipe Height: **9.6** (in.) Rod and Bar (Angled)
Pipe Material: **Clay** ☐ Pipe Lined
Invert Depth: **8.80** (ft.) Flow Characteristics: **Slow**
Deposits: ☐ None ☒ **Mud** ☒ **Sludge** ☐ Debris ☐ Grease
Silt Depth: **4** (in.) Deposits Extent: **Medium**
Infiltration: **None** Pipe Seal Cond: **Sound**
